## B0684x MAIN FIRMWARE RELEASE NOTES

### WM-Nano Table Top Automatic Wrapper with PK-260A CPU Board

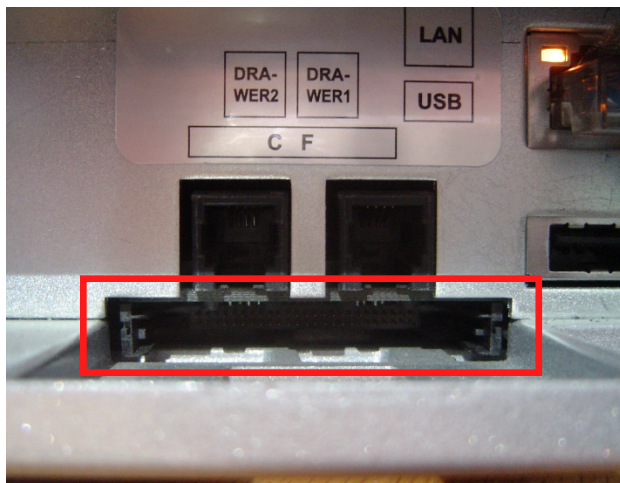
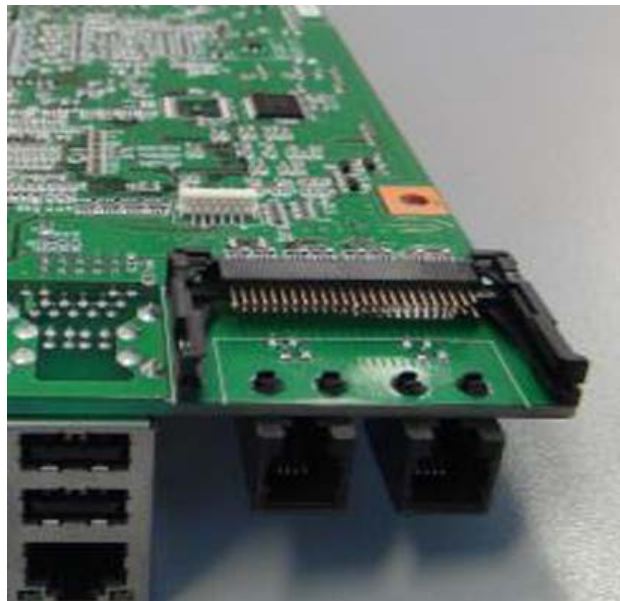
B0684x PK-260A with CF Memory Card Slot

Firmware B0684x is designed for the original CPU board PK-260A. **This firmware is not compatible with the revised CPU board PK-260B.** And new firmware (B0760x) is not compatible with the original PK-260A CPU board.

The two CPU board versions can be easily identified by the expansion memory card slot located on the left side of the Uni-7 controller. See the images on the next page.

The original PK-260A CPU board supports CF memory card sizes 512MB, 1GB, and 2GB (p/n 91870). The maximum CF card memory that can be recognized is 2GB. A larger capacity CF card may be used but only 2GB will be available.
