## B0684x MAIN FIRMWARE RELEASE NOTES

### WM-Nano Table Top Automatic Wrapper with PK-260A CPU Board

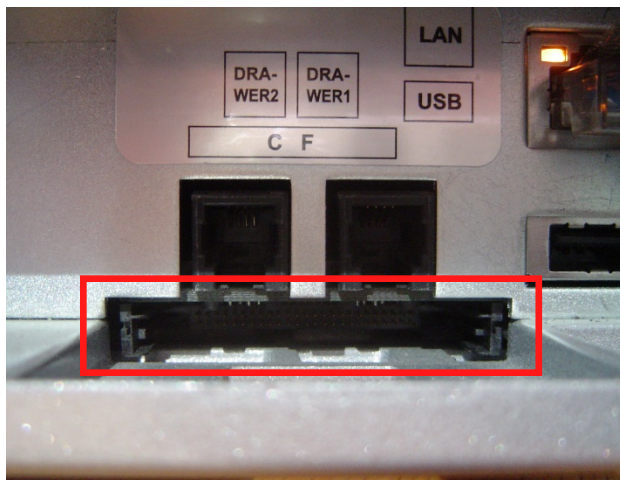
B0684x PK-260A with CF Memory Card Slot

The original PK-260A CPU board supports CF memory card sizes 512MB, 1GB, and 2GB (p/n 91870). The maximum CF card memory that can be recognized is 2GB. A larger capacity CF card may be used but only 2GB will be available.
